# **Mechanism of Fatigue in Micron-Scale Films of Polycrystalline Silicon for MEMS Applications**

***C. L. Muhlstein<sup>1</sup>, E. A. Stach<sup>2</sup>, and R. O. Ritchie<sup>1</sup>***

July 2001

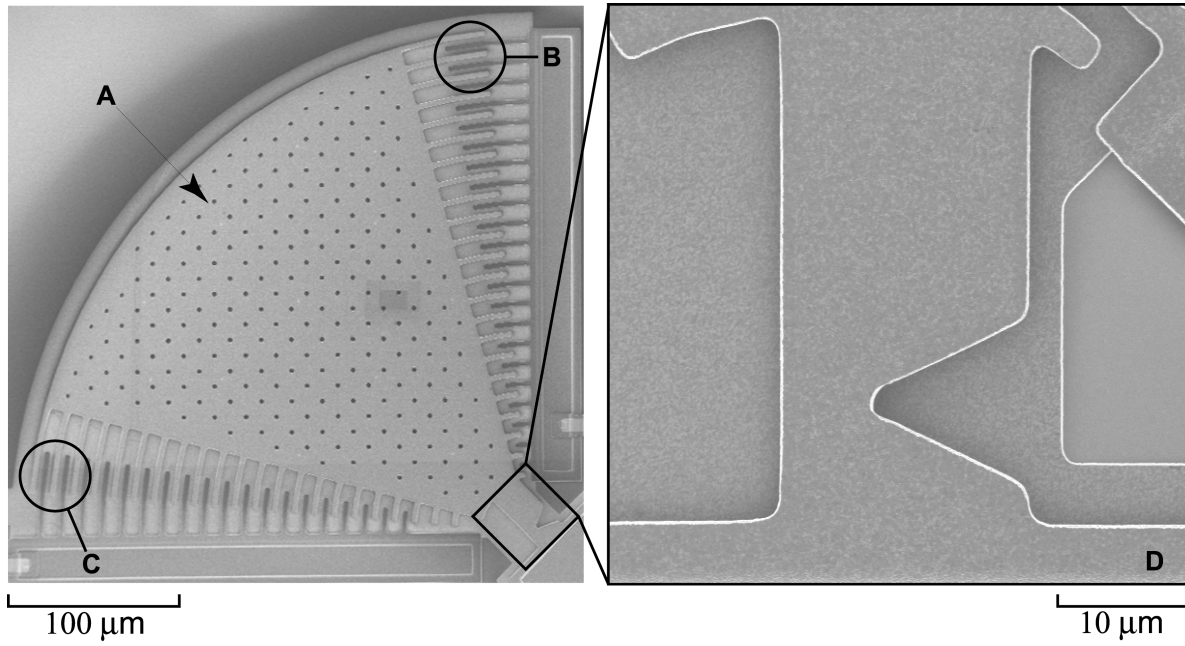
Figure 1 Scanning electron micrographs of the fatigue life characterization structure used in this investigation. The (A) mass, (B) comb drive actuator, (C) capacitive displacement sensor, and (D) notched cantilever beam specimen (inset) are shown. This 2 μm thick, surface micromachined structure was fabricated from LPCVD, n<sup>+</sup>-type, polycrystalline silicon.

If thin film silicon is fatigued at high enough stress amplitudes, cracks will initiate, grow, and the material will eventually fail. To characterize the mechanical properties of thin films such as these, an effective strategy is to manufacture the mechanical testing system directly from the material of interest. In our research we have used a micron-scale fatigue characterization structure that is analogous to the specimen, load frame, and displacement transducer found in conventional mechanical testing systems (Fig. 1) (7-11). This structure is reminiscent of the geometry used in commercially available inertial sensors and filters and therefore provides insight into their durability and reliability. The fatigue specimen is a notched cantilever beam that is in turn attached to a large ( $300\text{ }\mu\text{m}$

square) perforated plate that serves as a resonant mass. This simple harmonic oscillator is excited at resonance using electrostatic forces applied via one set of interdigitated “fingers,” or a “comb drive,” located on the edges of the mass. The opposing comb drive is used to measure the resulting motion. This tiny mechanical testing system applies large, fully reversed sinusoidal stresses at about 40 kHz to the material. The stress amplitude remains constant for a given test, but is varied across tests to characterize the behavior of the material. The natural frequency of the system is monitored; this frequency decreases as fatigue damage accumulates and eventually leads to failure of the specimen. If we plot the amplitude of the applied stress,  $\sigma_a$ , as a function of the number of cycles to failure,  $N_f$ , we generate what is referred to as a fatigue stress-life, or  $S/N$ , diagram, as shown for 2- $\mu\text{m}$  thick films of polycrystalline silicon in Fig. 2 (11). Note how the films can fail at stresses approximately one half of their (single cycle) fracture stress after large numbers of fatigue cycles. This information can be used for component design and life prediction, and for evaluating different forms of the material.

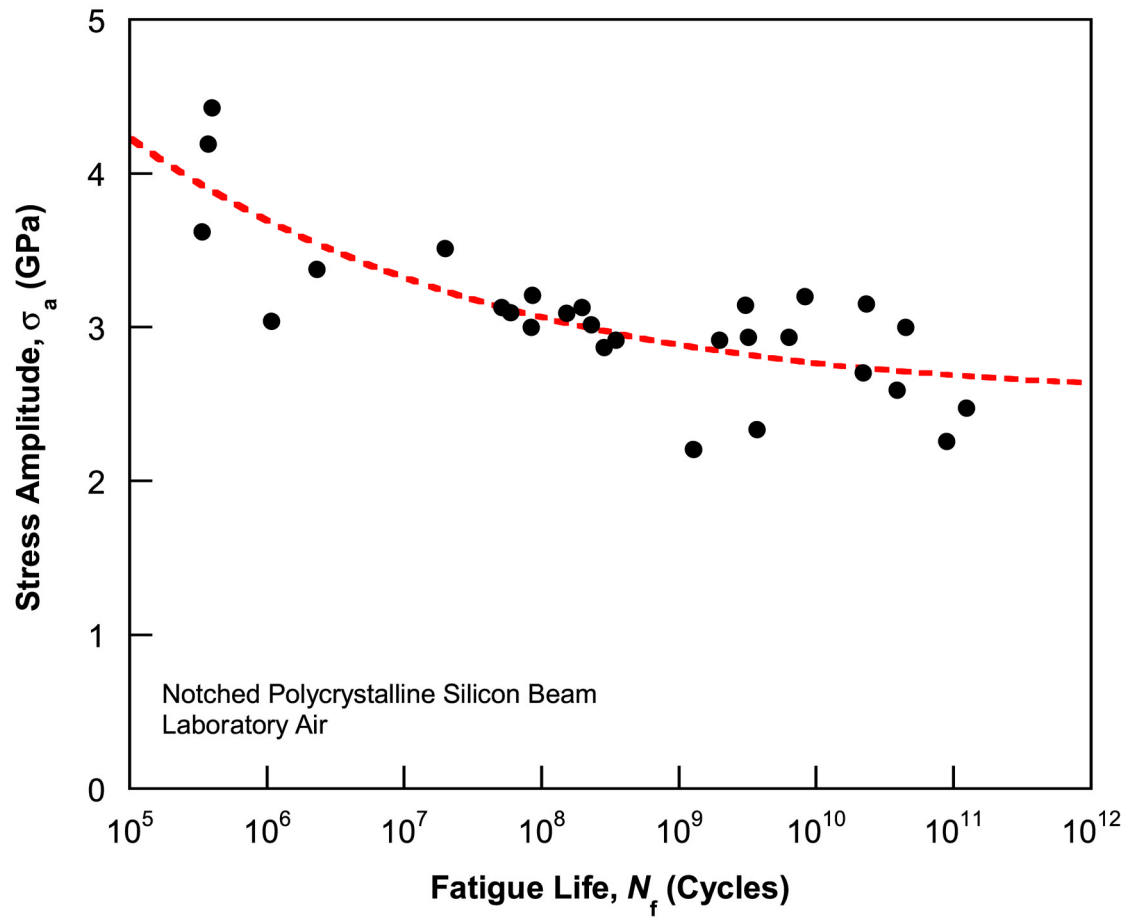
Figure 2 Typical stress-life ( $S/N$ ) fatigue behavior of the 2  $\mu\text{m}$ -thick, polycrystalline silicon at 40 kHz in moist room air under fully reversed, tension-compression loading (9,11). The dashed line is a fit of the stress-life power-law relation that is commonly applied to metals.

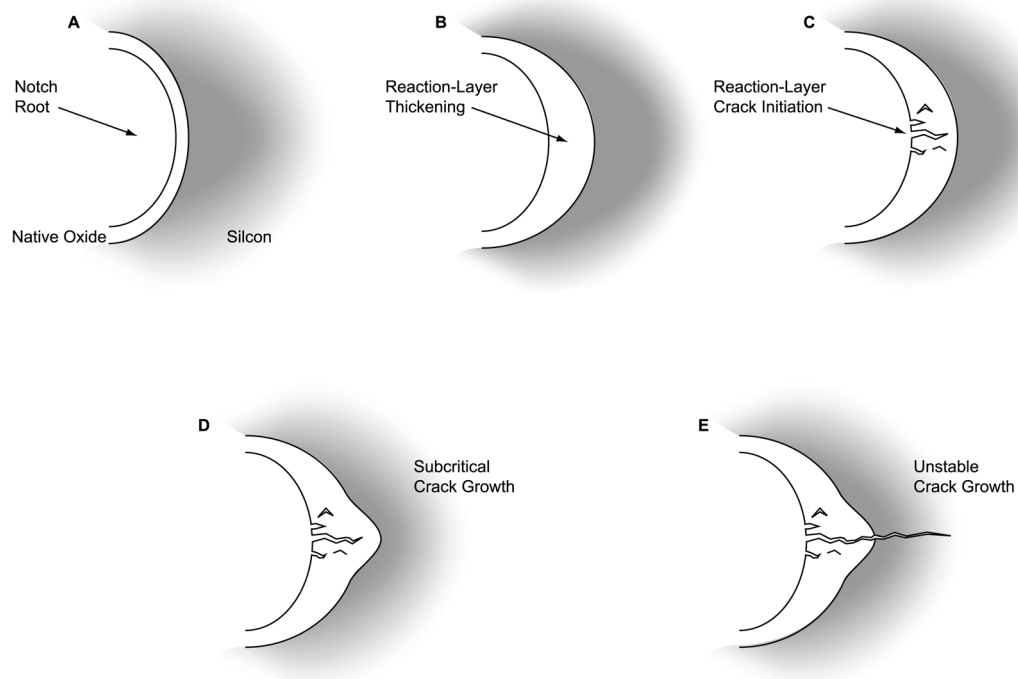
Figure 3 Schematic of the reaction-layer fatigue mechanism at the notch of the polycrystalline silicon cantilever beam. **(A)** Reaction layer (native oxide) on surface of the silicon. **(B)** Localized oxide thickening at the notch root. **(C)** environmentally-assisted crack initiation in the native oxide at the notch root. **(D)** Additional thickening and cracking of reaction layer. **(E)** Unstable crack growth in the silicon film.

Our research suggests that fatigue of silicon thin films occurs through a novel process of sequential, mechanically induced oxidation and environmentally-assisted cracking that we term *reaction-layer fatigue*. This progressive accumulation of fatigue damage, depicted schematically in Fig. 3, was observed experimentally as a continuous decrease in the stiffness of the specimen during fatigue loading (11) and was visualized directly using high voltage, transmission electron microscopy (HVTEM). Initially, a native oxide forms on the exposed silicon surfaces, with thickness and composition dictated by the environment and processing history of the thin film. In the case of the 2  $\mu\text{m}$  thick, low pressure chemical vapor deposited (LPCVD), phosphorous-doped ( $n^+$ -type)

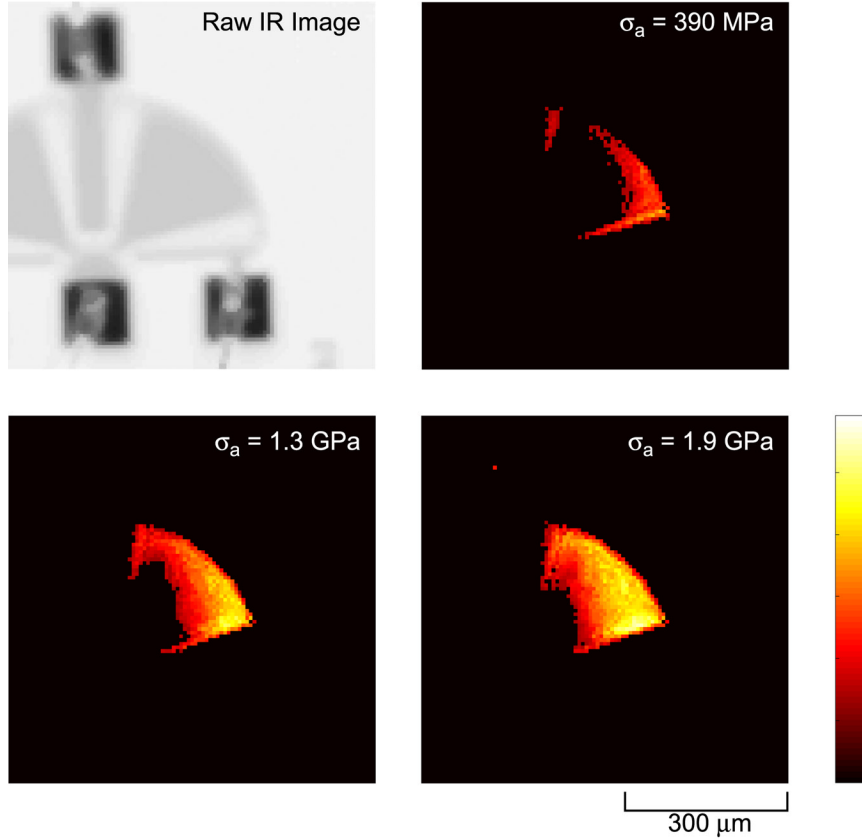
Figure 4 High resolution (20 mK) infrared (IR) images of the fatigue characterization structure. Each image was created by plotting the difference between IR images collected while the structure was resonated at the indicated stress amplitude,  $\sigma_a$ , and at rest. Individual IR images were collected by averaging over 2 seconds at an acquisition rate of 50 Hz. The absence of a difference in the IR images in the vicinity of the cantilever beam specimen indicates that the notch root oxidation process during reaction-layer fatigue is mechanical in origin. The slight warming of the mass is believed to originate from friction of the silicon with air as the structure resonates at  $\sim 40$  kHz and has not been quantified. The vertical scale represents temperature changes less than 1 K.

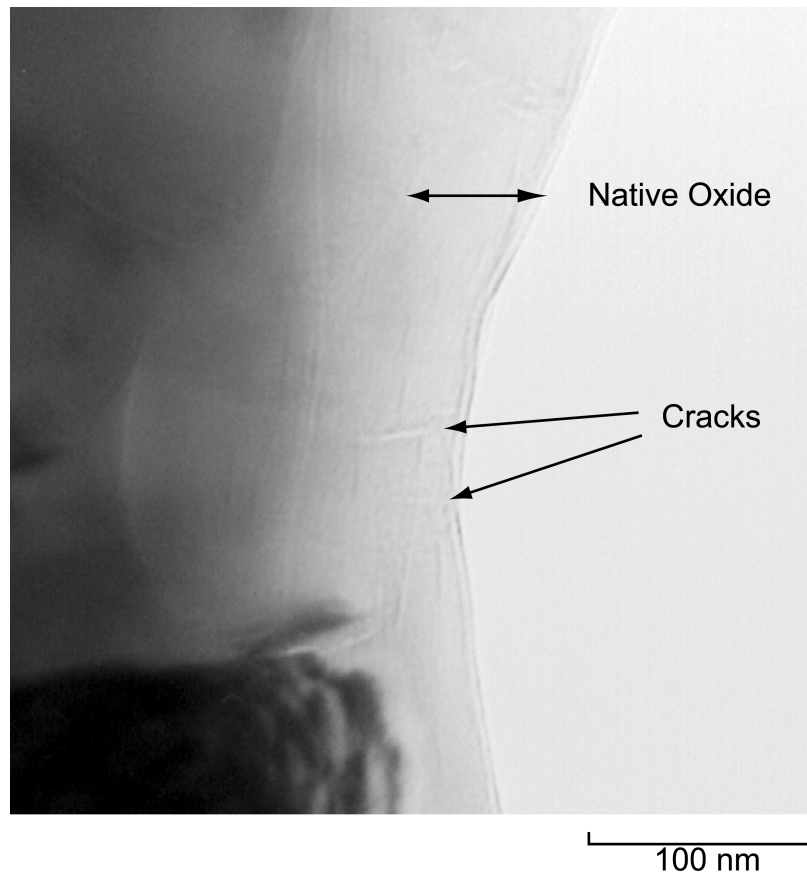
Figure 5 High voltage transmission electron micrograph (HVTEM) showing stable cracks in the native oxide of a notched, polycrystalline silicon beam formed during cyclic loading. Testing of this sample was interrupted after  $N = 3.56 \times 10^9$  cycles at a stress amplitude,  $\sigma_a$ , of 2.51 GPa. The micrograph was taken at 800 keV without thinning or other modification of the sample prior to imaging. The presence of cracks was confirmed by observation of the Fresnel fringes as the image was moved through focus, indicating an absence of material at the cracks. Furthermore, the size of the cracks is consistent with those predicted by numerical models of the experimentally observed damage accumulation. Prolonged exposure of the cracks to the 800 keV electron beam leads to healing of the cracks in a matter of minutes. This image was intentionally defocused to facilitate the observation of the cracks.

polycrystalline silicon used in this study, the initial oxide was about 30 nm thick. During subsequent fatigue loading, the oxide at the root of the notch thickened significantly. The oxide thickening process can cause up to a three-fold increase in amount of oxide at the notch, as documented using the HVTEM. One might expect this phenomenon to be attributed to heating induced by the high frequency loading and to be further accelerated by the tensile stresses. However, high-resolution infrared imaging of the fatigue characterization structure showed that while the temperature of the resonating mass may have warmed slightly due to friction with the air during cycling, the silicon specimen remained within 1 K of ambient (Fig. 4). Thus we believe that this oxide thickening process is *mechanical* in origin. Cracks are then initiated in the thickened amorphous layer assisted by the well-known vulnerability of amorphous SiO<sub>2</sub> to stress-corrosion cracking (14-16); indeed, these stable cracks were observed directly in the HVTEM (Fig. 5) by interrupting fatigue tests prior to failure. We believe that the fatigue of silicon proceeds via the propagation of these cracks by successive oxidation and environmentally-assisted cracking of the reaction layer, until a critical crack size is reached when failure occurs in the underlying silicon structure. In addition to the experimental data and HVTEM observations, numerical models also support this reaction-layer fatigue mechanism. Finite element models of the fatigue characterization structure (11) show that the change in resonant frequency and crack lengths observed experimentally are consistent with each other. Given this understanding of the mechanism of silicon fatigue, it is now possible to pursue our ultimate objective of engineering silicon films with superior resistance to fatigue failure.

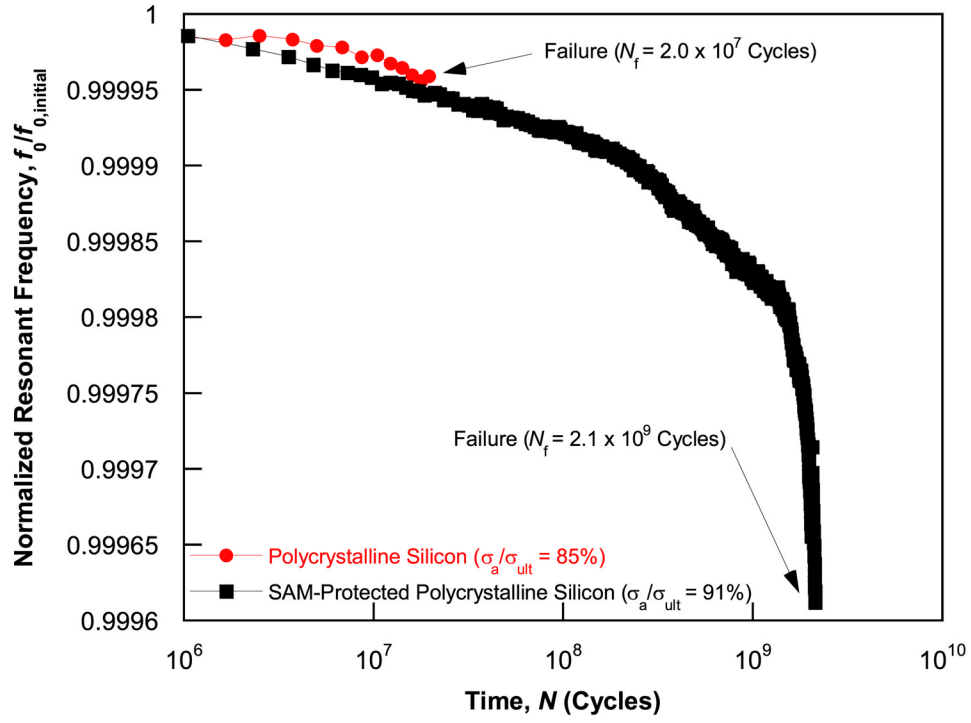
Figure 6 Damage accumulation in polycrystalline silicon and SAM-protected polycrystalline silicon thin films. The accumulated fatigue damage, i.e., notch-root oxidation and cracking, changes the natural frequency of the structure,  $f_0$ , as cycles,  $N$ , accumulate during the test. The accumulated damage with respect to the natural frequency of the structure at the start of the test,  $f_{0, \text{initial}}$ , is shown as a function of cycles,  $N$ , for both SAM coated and uncoated samples. The fatigue life of the SAM-protected silicon was improved by two orders of magnitude compared to uncoated silicon, despite being subjected to more severe fatigue loading conditions.

In order to test this theory, an alkene-based monolayer (1-octadecene,  $C_{16}H_{33}CH=CH_2$ ) was applied to the polycrystalline silicon fatigue characterization structure before the native oxide formed. This was achieved by creating a hydrogen terminated surface using aqueous HF and applying the SAM in a reactor containing a solution of one part 1-octadecene in nine parts hexadecane (17). This hydrophobic, self-assembled monolayer (SAM) bonds directly to the (hydrogen-terminated) surface atoms of the silicon film (no oxide is allowed to form) and acts as an effective barrier to oxygen and water (17). We hypothesized that if the silicon does, in fact, fatigue by the reaction-layer mechanism, preventing formation and stress corrosion of the native oxide should suppress fatigue failures. Initial results on SAM-protected polycrystalline silicon confirmed that lifetimes were not affected by the applied cyclic stresses. Indeed, as anticipated, damage accumulation was dramatically altered and fatigue lives considerably extended in the coated samples (Fig. 6); this provides additional support for the proposed mechanism. One should note, however, that there is an unexpected penalty for using the SAM for suppressing fatigue failures. Although the coated films do not appear to be as

susceptible to premature failure by fatigue, their (single cycle) fracture strength is degraded. For example, the average fracture strength of the SAM coated polysilicon was 2.6 GPa compared to 3.9 GPa for the uncoated polysilicon. It is believed that the native oxide smoothes the surface of the film, whereas its suppression leaves extremely thin, sharp features that lower the strength (due to stress concentration). Such degradation in strength was not observed in previous testing of perfluorodecyltrichlorosilane (PFTS) and octadecyltrichlorosilane (OTS) SAM coatings on polysilicon (18). In principle, there are two methods for avoiding this problem. First, the processing of the film may be refined to improve its surface roughness. A more pragmatic approach, however, may be to use a hydrophobic layer on the native oxide. This would act to smooth the film surface through the presence of the initial oxide layer, yet at the same time restrict further access of the environment, thereby suppressing the formation of stress-corrosion cracks and hence inhibiting fatigue damage in the silicon film.
